Appendix 2 – Narrative Risk Assessment (September 2021)

Farnborough North Level Crossing Narrative Risk Assessment

September 2021

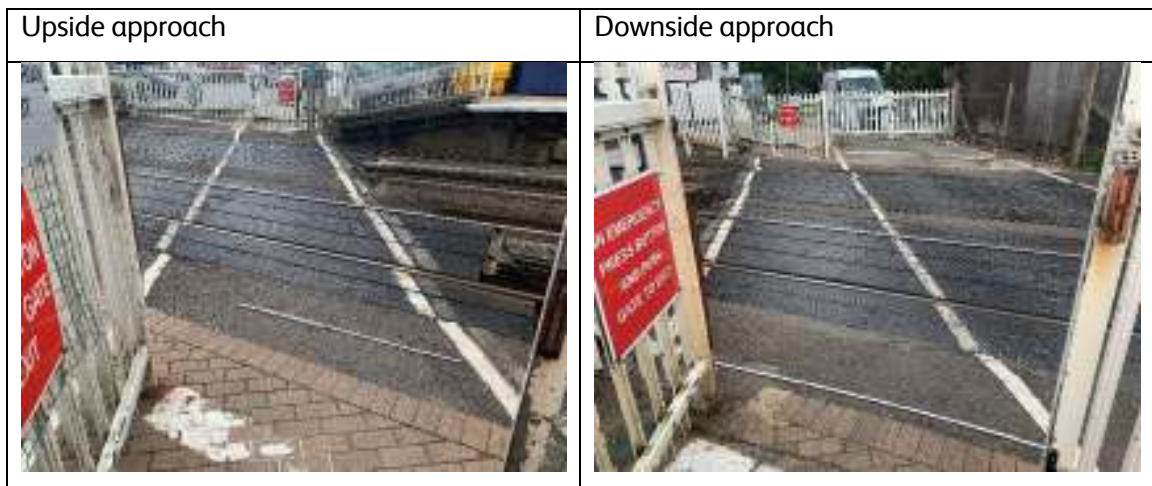
- 2.4.14 Within the crossing limits there are signs stating ‘pedestrian exit’ and ‘in emergency press button’ and ‘push gate to exit’ on both gates. There is a green push button next to the gates that will release the magnetic locks if a pedestrian user gets trapped when the gates are locked.
- 2.4.15 Signs have been vandalised in the past and the LCM replaces the signs when required.
- 2.4.16 Telephones are positioned at the crossing approaches in event that the MSL fail, and users are instructed to phone crossing operator. The telephones are also there for the user-worked crossing to contact the crossing operator before crossing.

- 2.4.17 Ground conditions continue to reflect the approaches and are fully tarmacked on both approaches.
- 2.4.18 The Crossing deck is made of a rubberised material offering extra traction over the railway. Either side of the deck are fitted timber anti-trespass guards. The Crossing has self-closing gates on both approaches. With the deck being level to the rails, with excellent approaches and deck, with no tripping or slipping hazard, displaying correct signage, and crossing attendants, there are no other mitigations that can be employed to further mitigate residual risk.

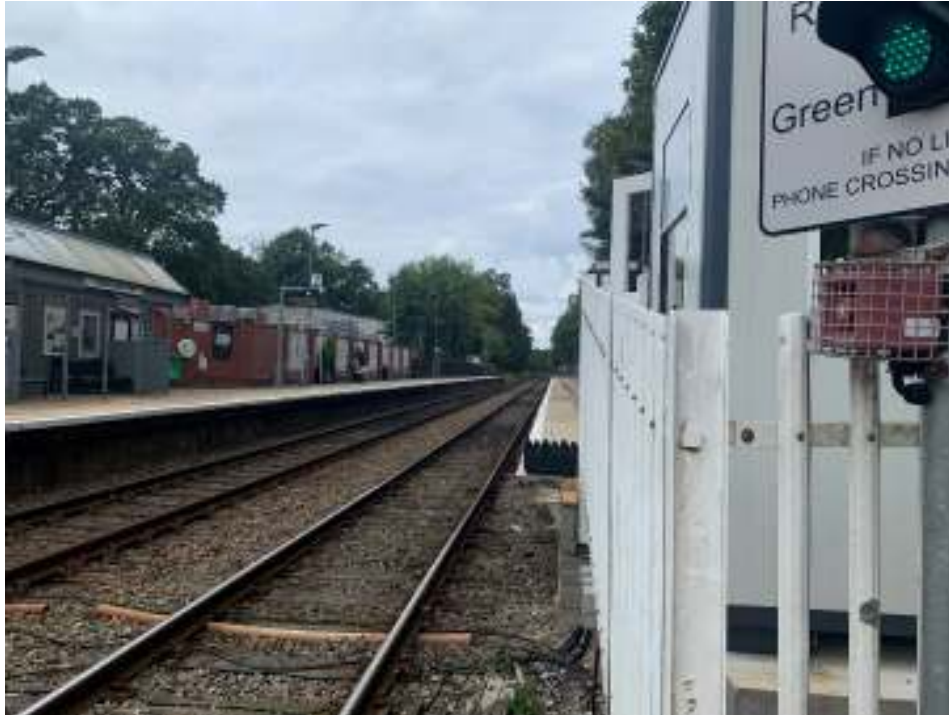
2.7.8 Upside, Up direction train approach at 1.2m Decision Point

- 2.7.7 The sighting measurements taken from the Decision Point at the time of the assessment (by laser rangefinder) are set out in the table below. Sighting is non-compliant with the minimum required sighting in one direction for vulnerable/incumbent users, as mentioned above, this has been increased by 50%.

Required Minimum Sighting for 12.62s traverse time	Ideal Sighting Distance	Measured Sighting	Actual Warning time	Measured from crossing to?
Upside looking towards Up direction train approach	395m	489m	489m	15.62 s	Vegetation on upside curvature
Upside looking towards Down direction train approach	395m	489m	366m	11.71s	Vegetation on upside curvature
Downside looking towards Up direction train approach	395m	489m	437m	13.97s	Vegetation on upside curvature

All of these sighting calculations become irrelevant if Crossing users obey the MSL. It forms the over-riding mitigation by providing a direct indication to the user of an approaching train so that the user no longer is required to look for approaching trains.

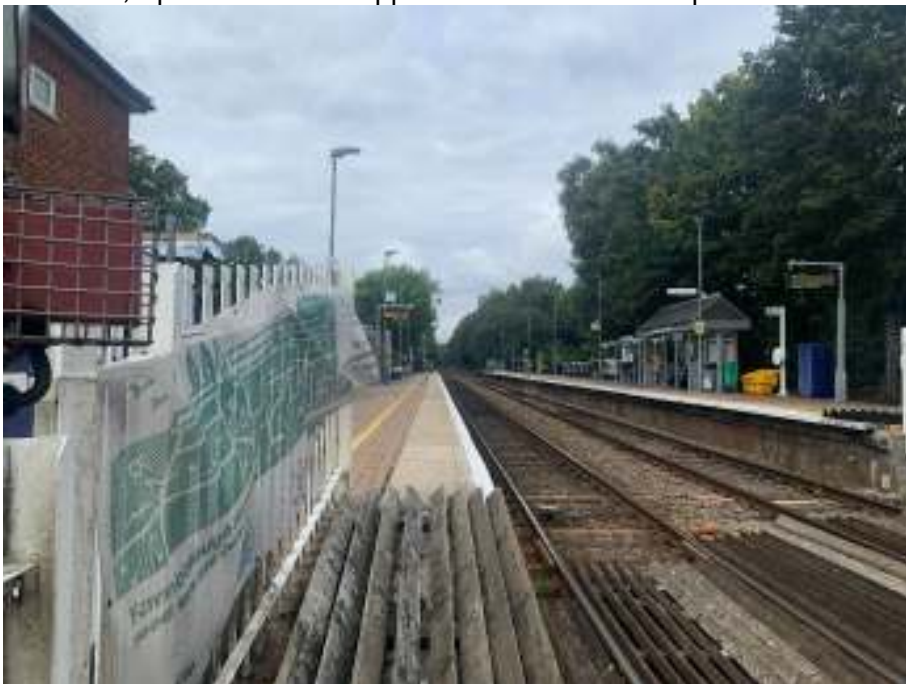
2.7.10 Downside, Up direction train approach at 1.5m decision point

Downside looking towards Down direction train approach	395m	489m	309m	9.87s	Vegetation on upside curvature
--	------	------	------	-------	--------------------------------

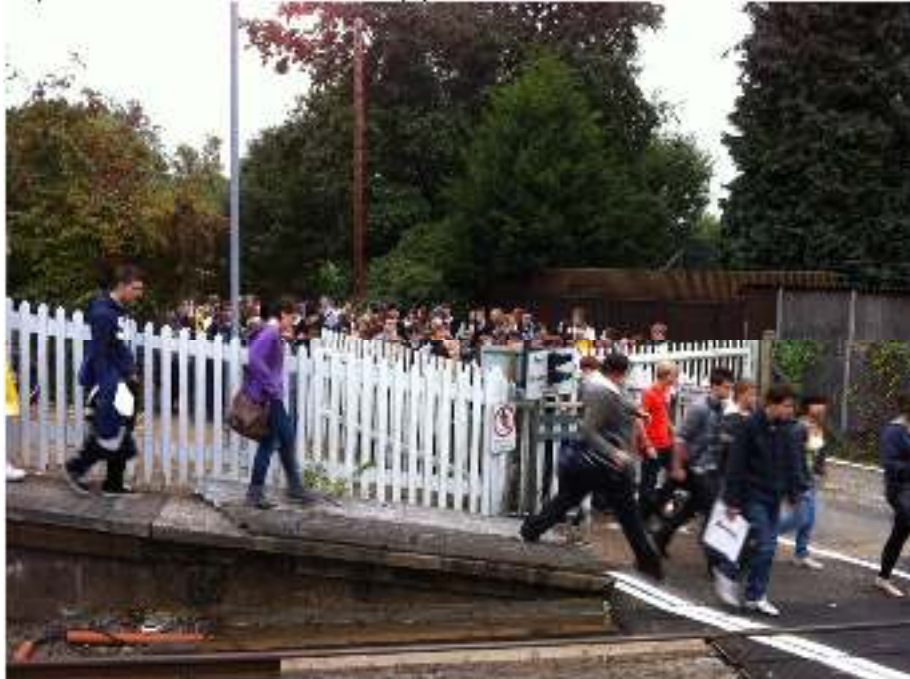
2.8.10 The picture below shows the set-up prior to the introduction of the attendants

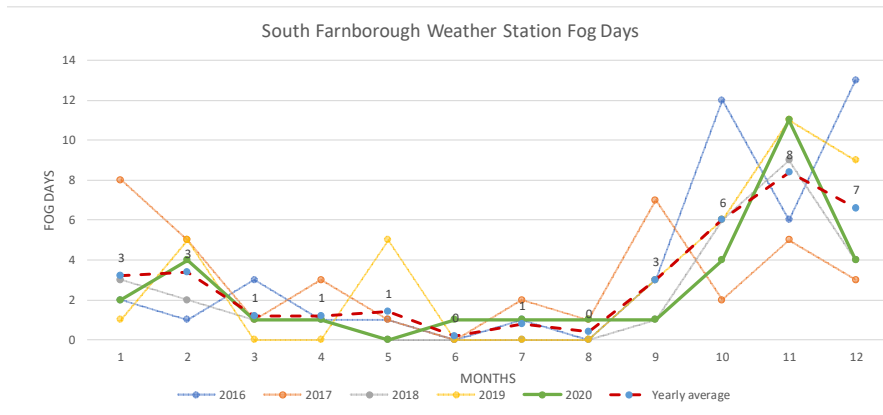
South Farnborough Weather Station Fog Days

2.14.5 Below is a graph from the nearest weather station (South Farnborough) to the Crossing highlighting recorded fog conditions at the crossing for the last 5-years.

2.14.6 The data shows that during the colder months of the year Farnborough North is more susceptible to fog days. It has been noted by the LCM that cold days with little to no wind can result in the area suffering from fog that can last for several hours, with particular build ups in the morning hours.

2.14.7 It is noted that the MSL combat the fog which would have to be extremely dense to disguise the MSL output.

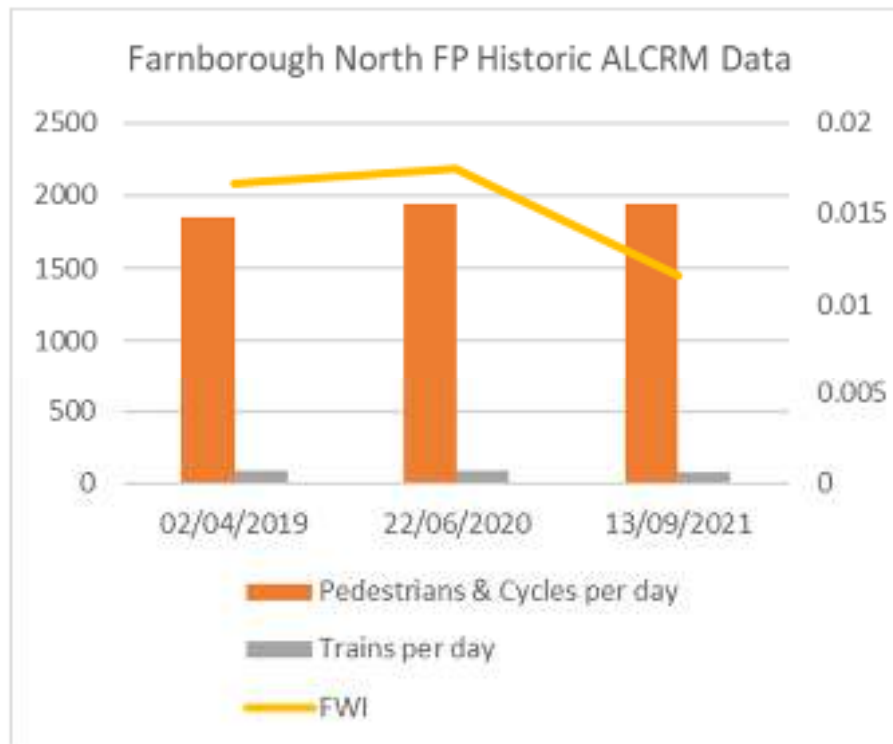
3.11 The historic ALCRM data below shows a slight increase in FWI between 2019 and 2020 which is attributable to increases in pedestrian & cycle users per day. There is a steep decrease between 2020 and 2021 which is attributable to the ALCRM algorithms more accurately reflecting risks at crossings.

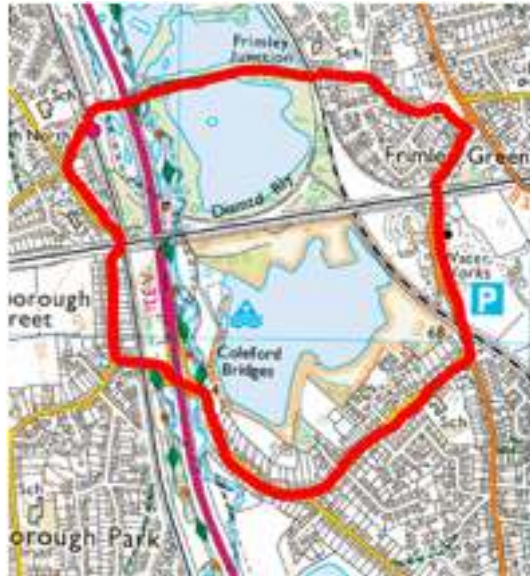
- 4.4.5 The diversionary route highlighted in red below is 2.4 miles.

- 4.4.4 A simple extinguishment would allow no other means for commuters to access the station platforms from one side to the other, as well as break the cross-community link between Frimley and Farnborough.
