**NARRATIVE RISK ASSESSMENT – PASSIVE TEMPLATE FINAL v1.0**

**PASSIVE LEVEL CROSSING RISK ASSESSMENT**

This is a risk assessment for Chandlers Ford level crossing.

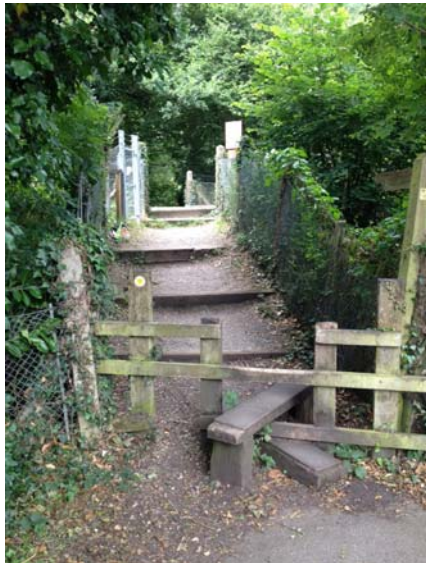
**Up side crossing approach**

Chandlers Ford is a public footpath level crossing which is located on Sutherlands Way in the overgrown village of Chandlers Ford in the Borough of Eastleigh. A station can be seen from the level crossing at approximately 120 metres. The crossing covers a single bi-directional non-electrified track with no curvature.

The approaches on both sides have two up two down stepped stiles with non-slip material applied which are in a good solid condition which lead onto steep large uneven steps made up of earth and timber which can prove slippery in adverse weather conditions. It is suggested that type 2 tarmac is installed to give a more level stepping area with less trip hazards. There is wing fencing on both sides which is in good condition. The crossing surface is timber decking with non-slip material, painted white edge lines and there are trespass guards in situ.

**Type 2 Tarmac applied to steps is a short term recommended option.** There is no BCR or safety benefit therefore funding would need to be sourced as the steps here are not deemed unsuitable for use by the maintenance team. They are in keeping with the surrounding walkways approaching the crossing on the downside, for this to move forward the highways side would need to be upgraded at the same time.

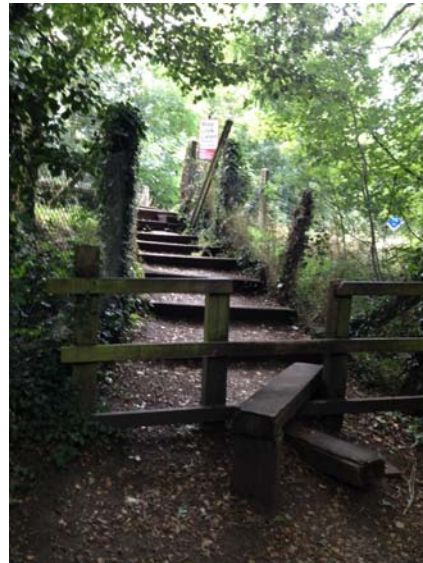
**Down side crossing approach**

The environment surrounding Chandlers Ford level crossing is between two housing estates with a small nature reserve for dog walkers and bird watchers on the downside. This is a heavily used crossing as a cut through to the local shops and for the use of the nature reserve.

There was a redundant metal post embedded into the earth on the down side that has been removed giving better visibility of crossing signs. The road on the up side can be noisy at peak times with vehicles and regular passing buses.

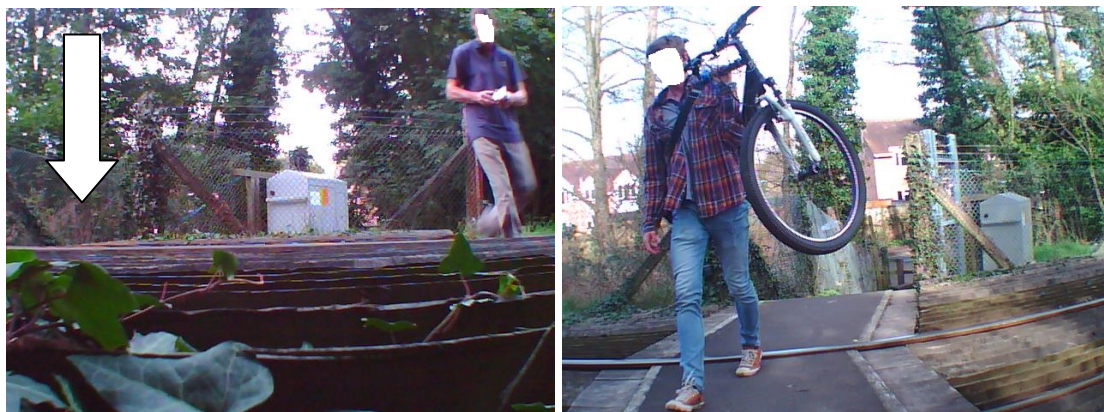
Installation of cameras at this crossing show it is heavily used by cyclists who have to carry their bikes across here, it is a crossing which is used at night and shows people crossing the trespass guards to walk up and down the track.

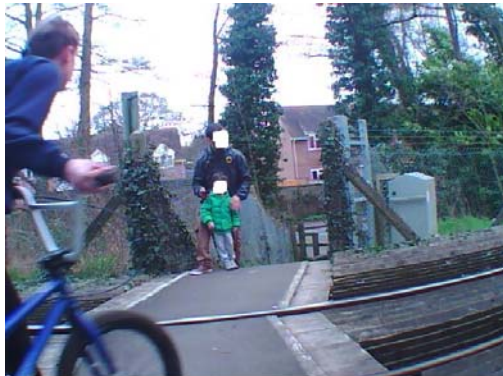
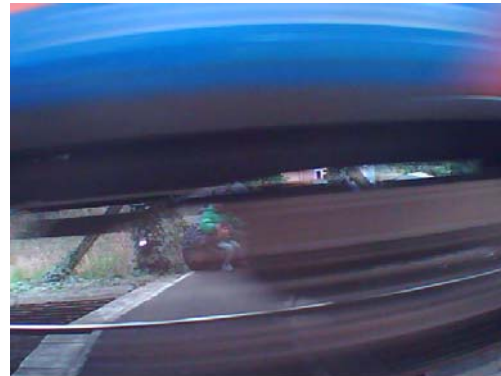
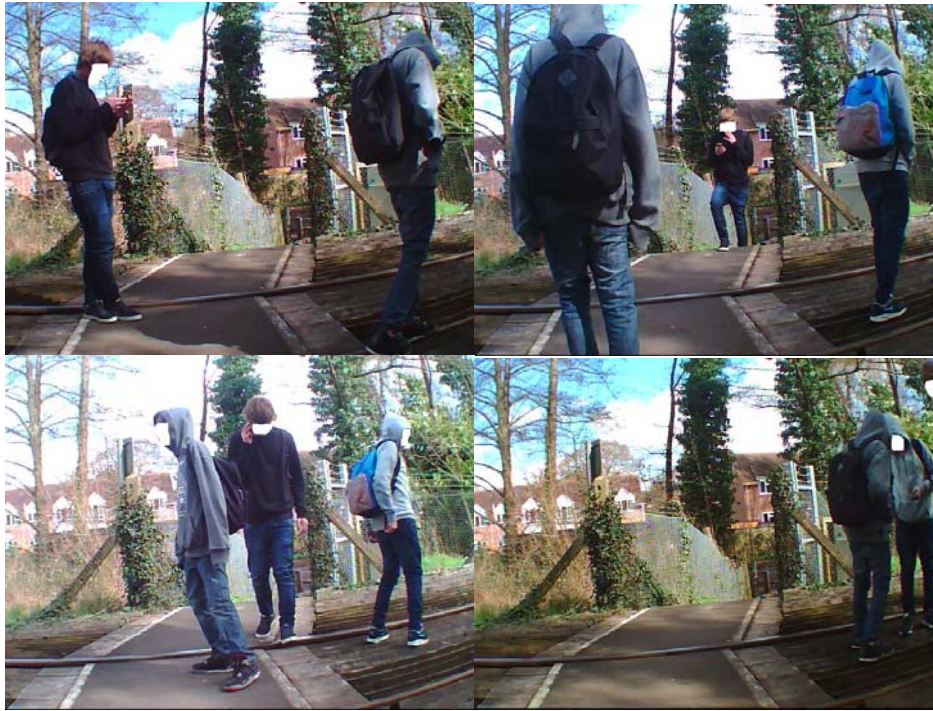
People coming from the crossing and station to walk up and down the track as a short cut and youths trespassing is a frequent occurrence.

**Education and awareness days are short term recommended options.** Discussions have taken place with the local Community Safety Manager to promote safety at this crossing with local schools being approached, with a plan being worked up. The next ILCAD is to be held at this site, with a focus being on Pedestrians and Cyclists after which leaflet drops can be carried out in the area.
