LONG-TERM REAL-TIME MONITORING

Forest Lodge Home Farm
Prepared for: TJ Transport Limited
Client Ref: 00492

SLR Ref: 416.00492.00026
Version No: 1
November 2020

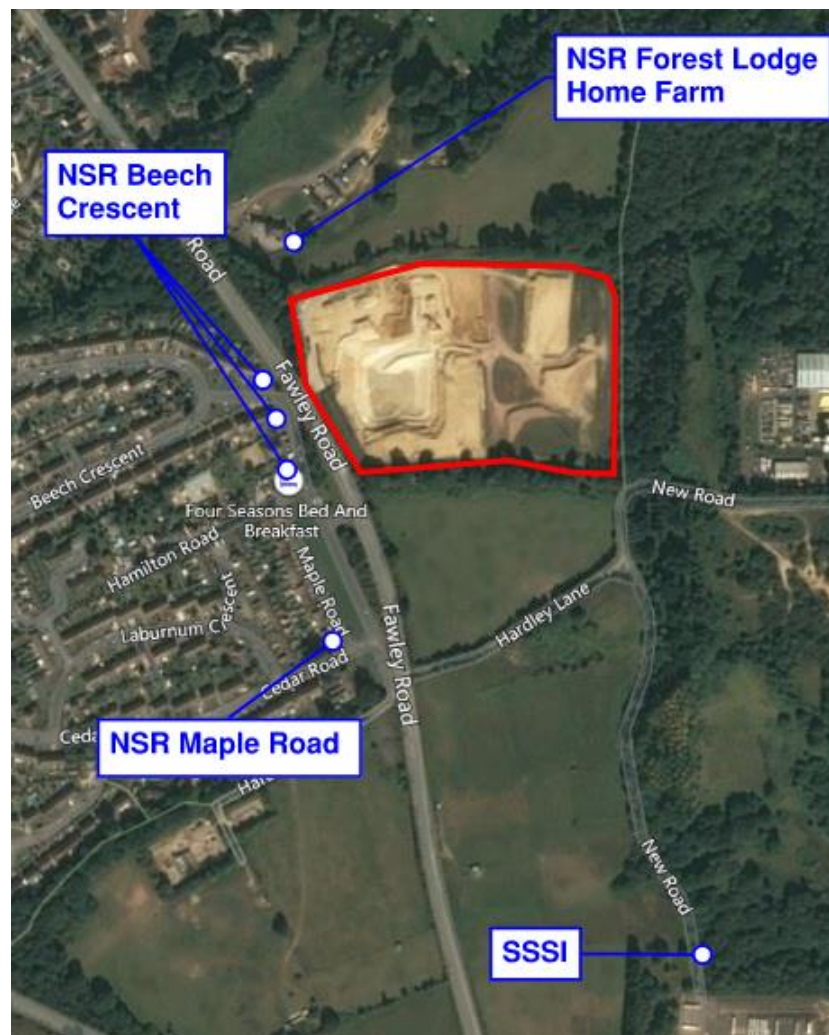
Figure 2-1
Site location and NSRs

The approximate site boundary is shown in red and the NSRs are given in blue in Figure 2-1.

The monitoring location shown in Figure 3-1 is closer to the working area than the nearest noise-sensitive receptors shown on Figure 2-1.

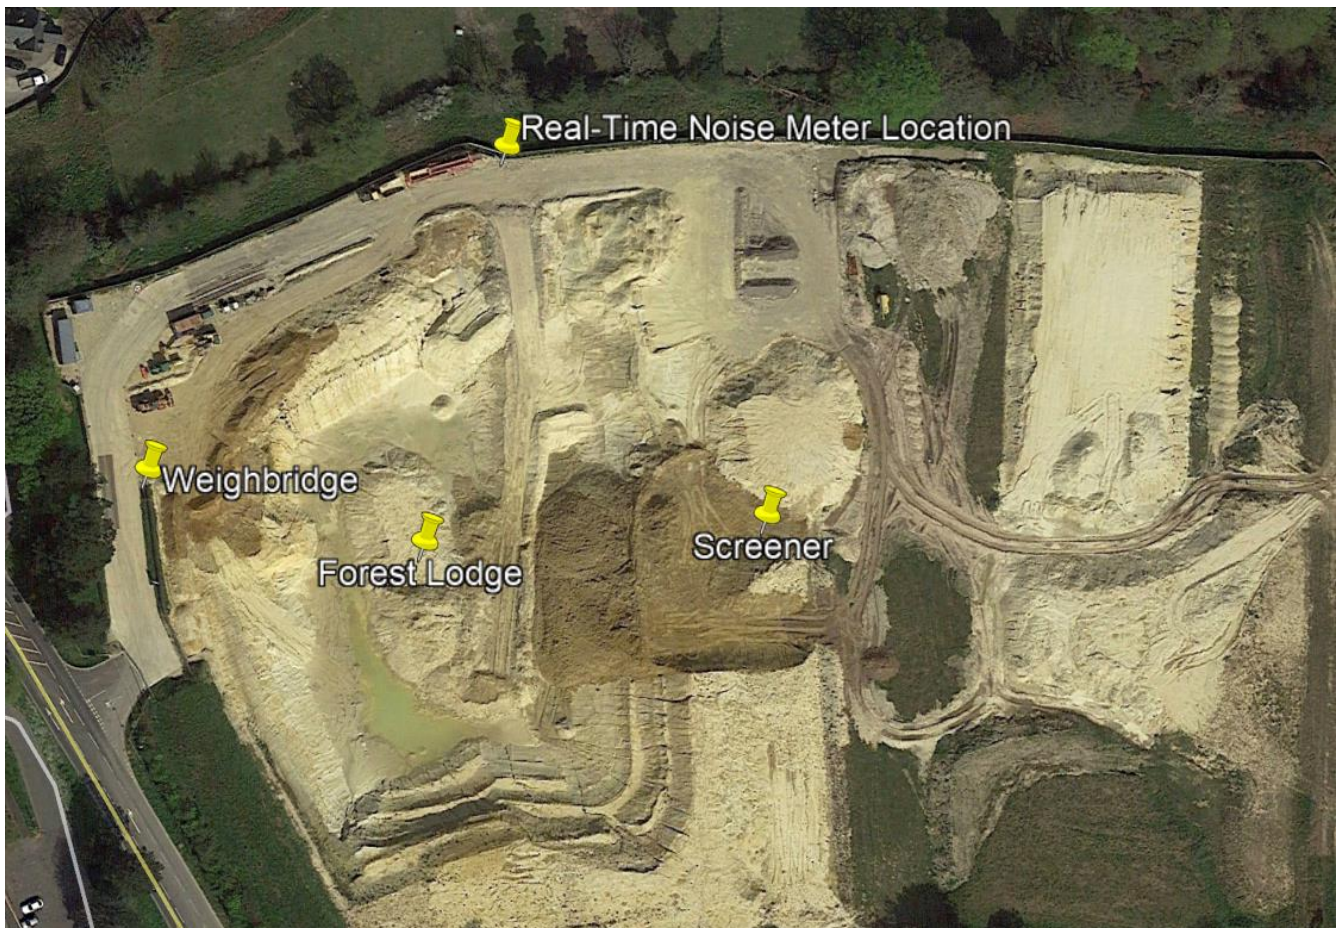
Figure 3-1
Monitoring Location

The sound level meter was installed at a location on the northern boundary of the Site, at a location representative of the western extents of phase 2, as shown on Figure 3-1 below.

The approximate location of the screener, which is considered to be the main noise source at the Site, and the location of the weighbridge is also shown on the image.

As shown on Figures 2-2 and 3-1, extraction operations are currently being undertaken in phase 2 part of the quarry with the screener located towards the centre of the Site.

The surveyor therefore chose the position shown on Figure 3-1, as the noise from Site operations was prominent, and the noise environment was not significantly influenced by road traffic noise from Fawley Road. The main noise sources from the quarry consisted of the screening of material and mobile plant movements.

The selected location is also adjacent to the haul route, which is utilised by mobile plant travelling from the Site compound to the working area within the quarry and by tipper lorries accessing the Site, consequently worst-case noise levels from vehicle movements are also being captured.

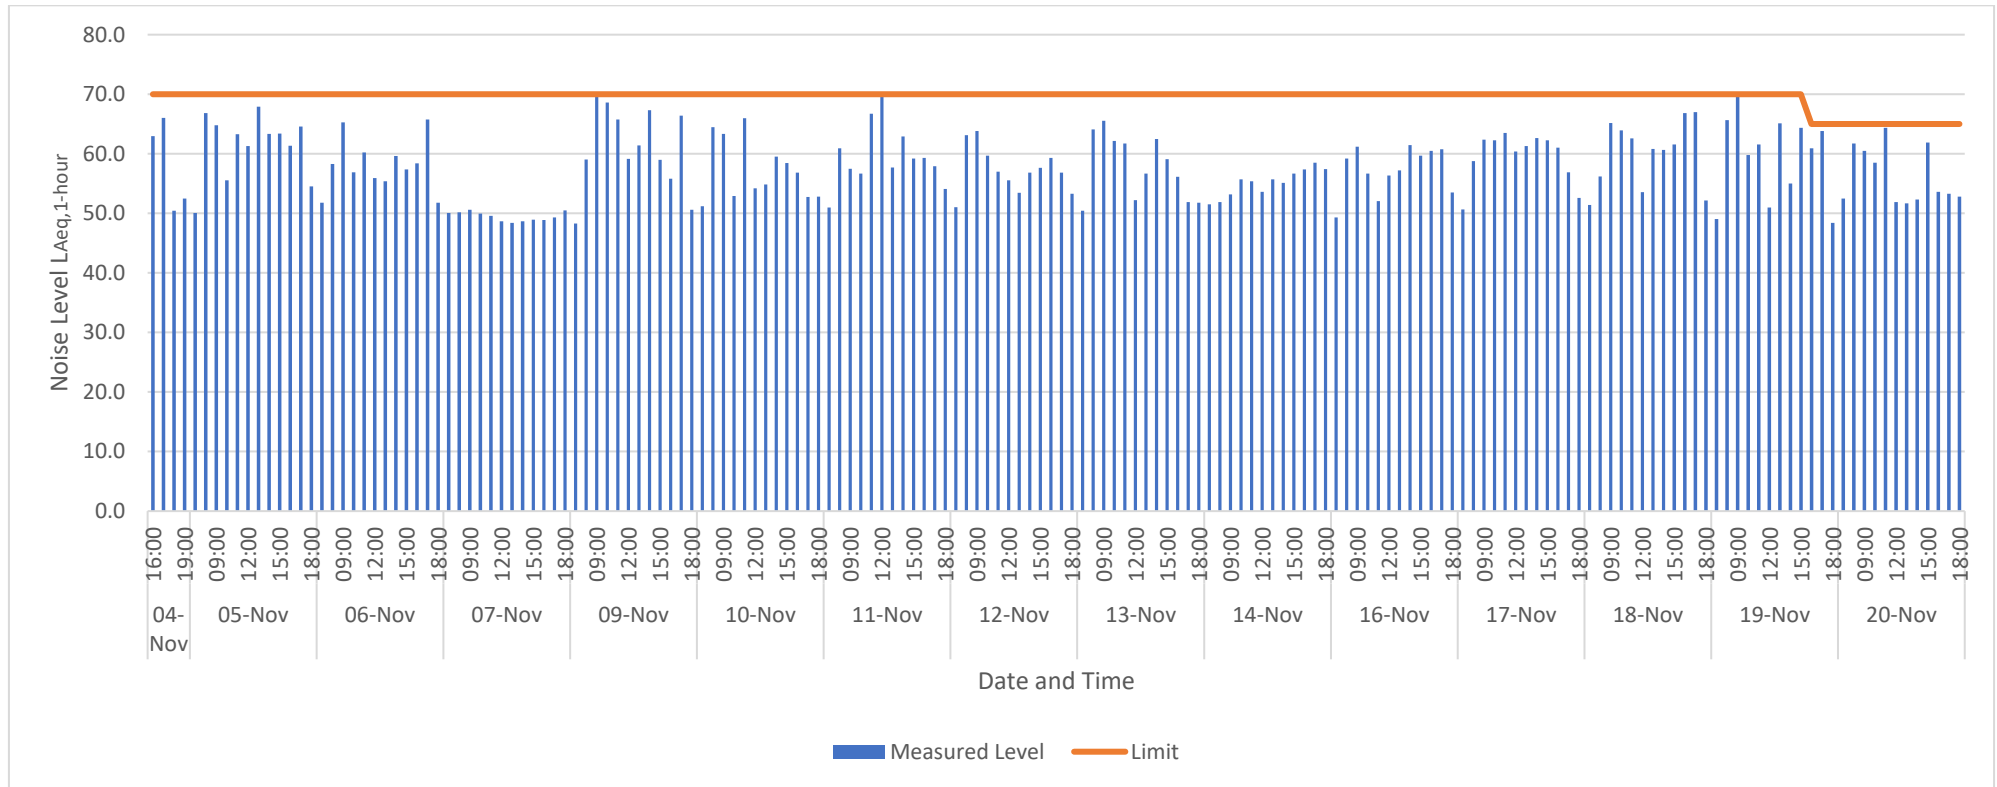
Figure 02-1
Measured Noise Levels, dB

The measured noise data is presented in graphical form in Figure 02-1 in Appendix 02. It must be noted that no data is presented after Friday the 20th of November as the batteries in the meter ran out of power during the morning of the 21st of November 2020.

The data for Sunday the 8th and 15th of November is also not shown on the graph as the Site was not operating during these periods.

It can be seen from the graph that the noise limit was exceeded on the following occasion;

- Between 09:00 and 10:00 on Thursday the 19th of November 2020.

SLR has listened to the audio file for the above period and it was determined that the exceedance was due to items of mobile plant passing the monitoring position.

From further analysis of the data it can also be seen that during the early morning periods (09:00 to 11:00) the measured noise levels are typically higher, this can be explained as during these periods the mobile plant is travelling from the Site compound to the working area.
